# Debris/Ice/TPS Assessment and Integrated Photographic Analysis for Shuttle Mission STS-54

(NASA-TM-107558) DEBRIS/ICE/TPS  
ASSESSMENT AND INTEGRATED  
PHOTOGRAPHIC ANALYSIS FOR SHUTTLE  
MISSION STS-54 Final Report, 12-21  
Jan. 1993 (NASA) 146 p

DEBRIS/ICE/TPS ASSESSMENT  
AND  
PHOTOGRAPHIC ANALYSIS  
OF  
SHUTTLE MISSION STS-54

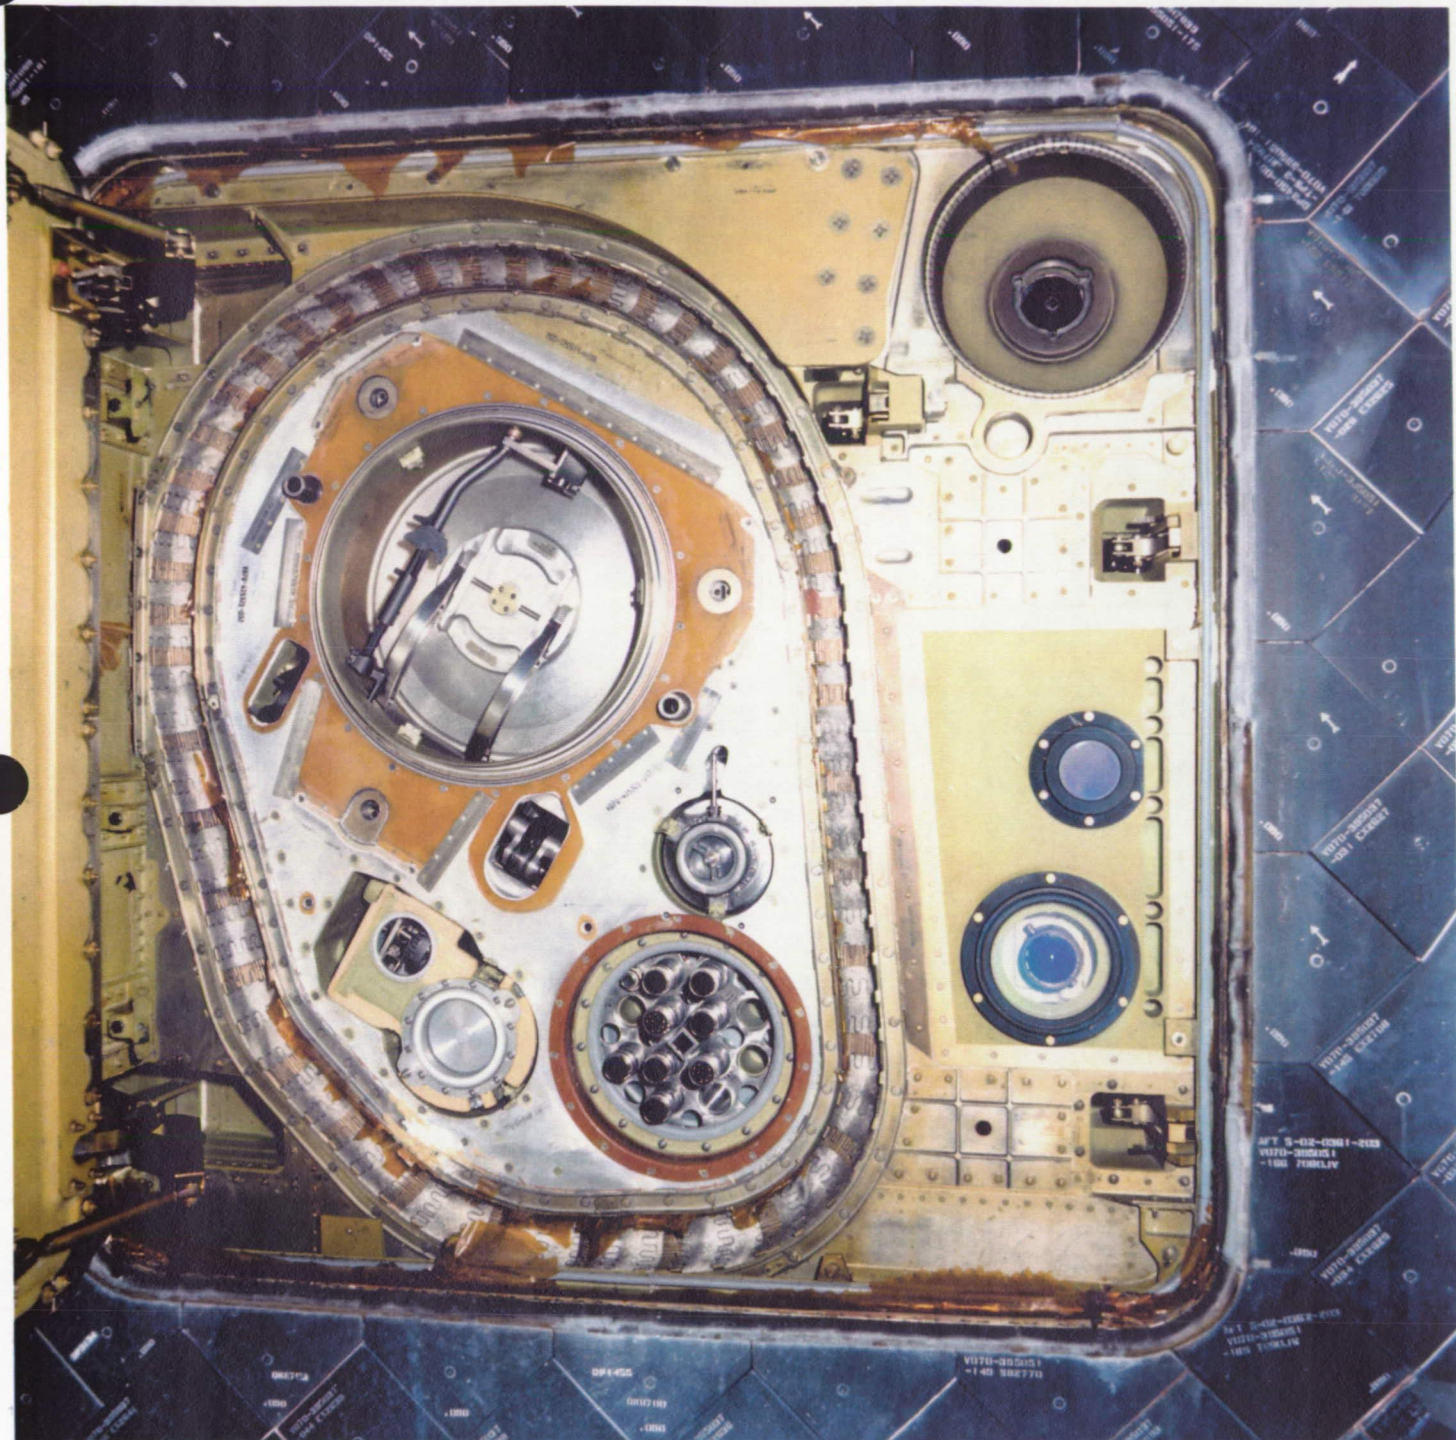
Overall view of the LH2 ET/ORB umbilical. All separation ordnance devices functioned properly. No flight hardware was found on the runway below the umbilical when the ET door was opened.

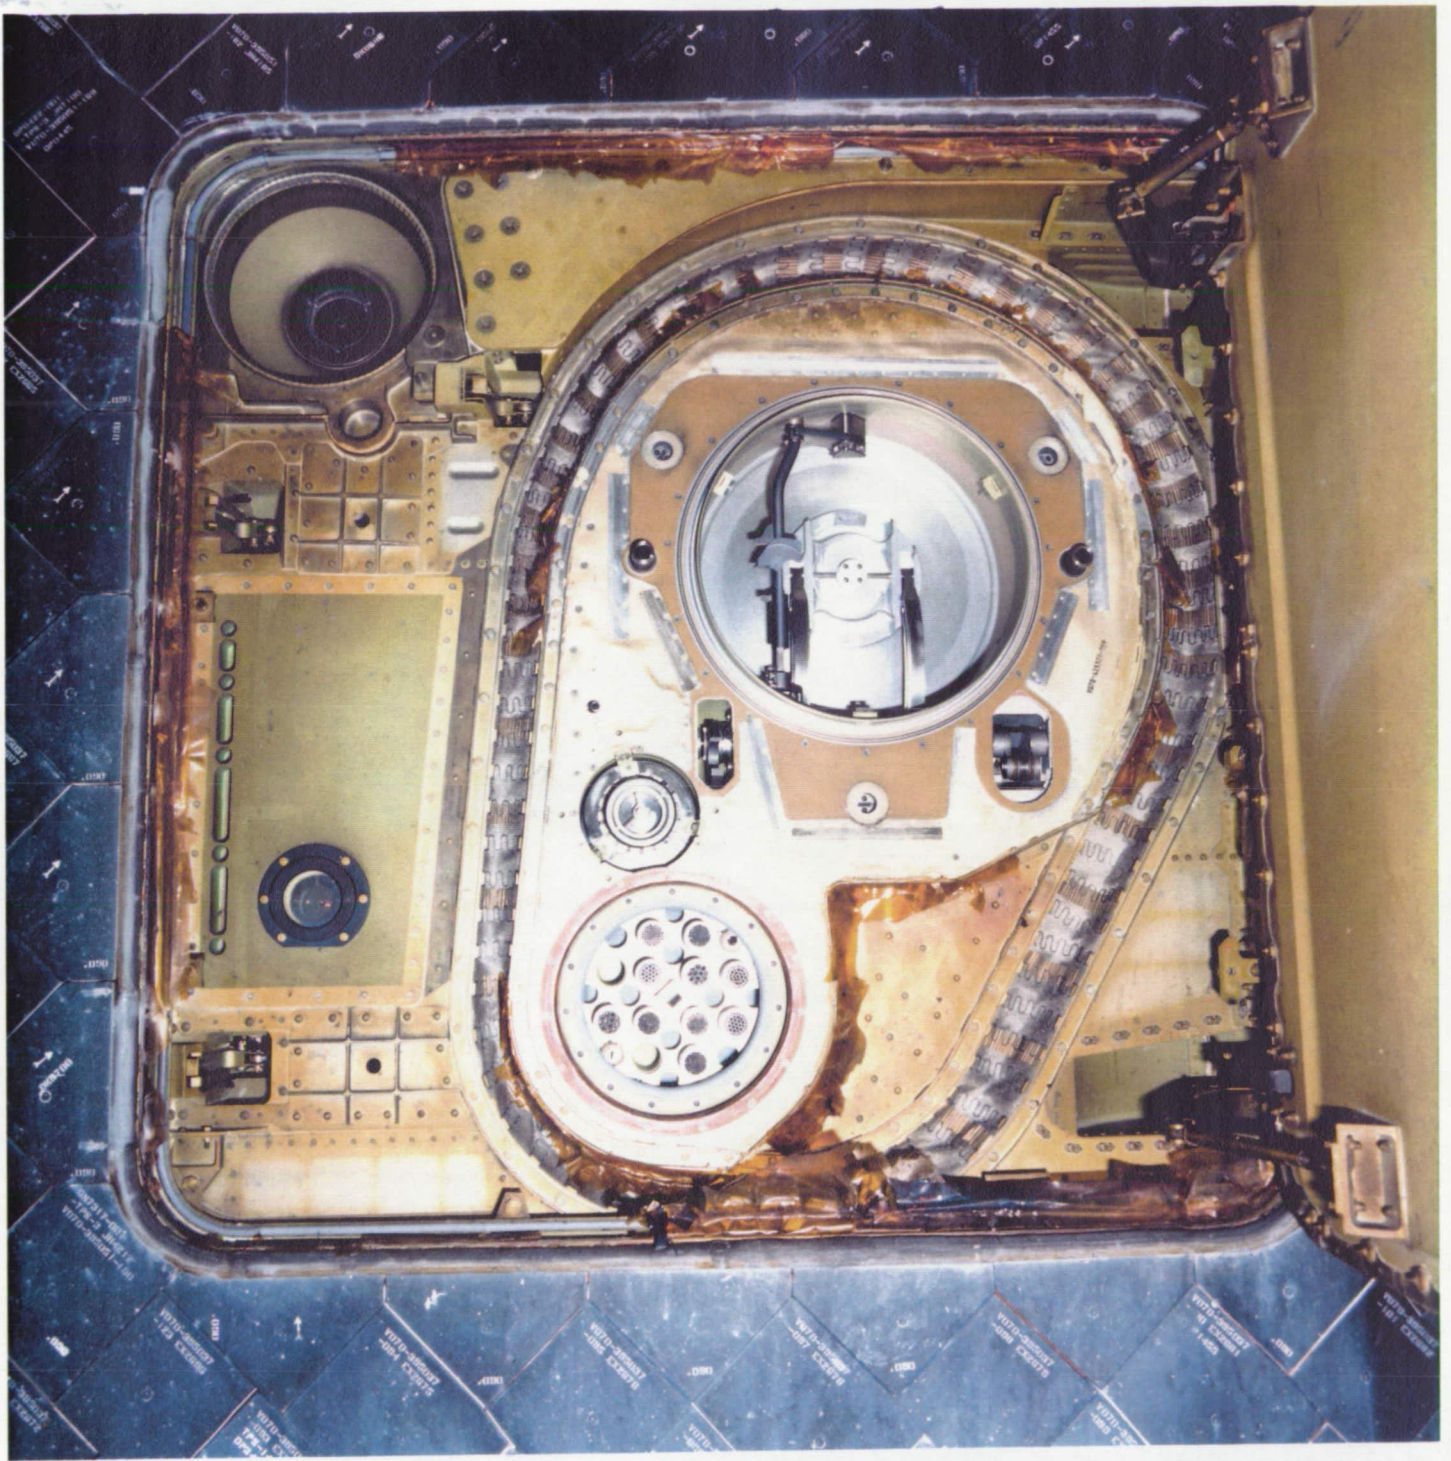
Overall view of the L02 ET/ORB umbilical. All separation ordnance devices functioned properly. No flight hardware was found on the runway below the umbilical when the ET door was opened.

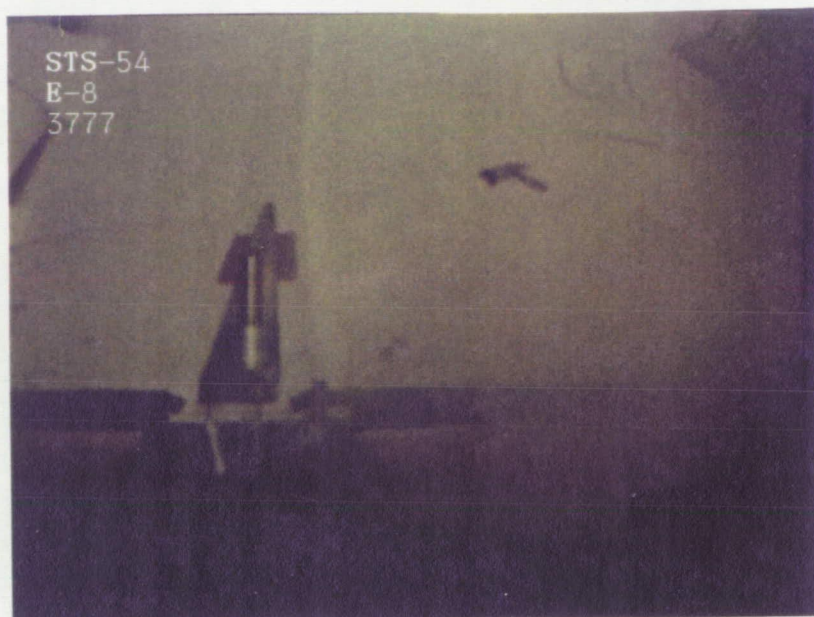
**Figure 2.1.2.1 Flexible Debris from SRB Flame Duct**

As on previous missions, several pieces of debris were noted originating from the Solid Rocket Booster (SRB) flame duct area after SRB ignition.

The size and velocity of two pieces of debris that apparently came from the SRB flame ducts were measured. The first piece of debris was a large piece of tape-like debris (possibly thermal curtain tape) seen coming from the right SRB flame duct at liftoff. The position of the debris was digitized for 31 frames from camera E-8. The scale marker on the shoe of the SRB holddown post was used for scale and the object was assumed to be moving in the same plane (i.e. the same distance from the camera) as the M-2 holddown post. Velocity was determined by fitting a linear regression line to the distance of the debris from its initial position versus time. The slope of the regression line was then used as the velocity of the debris. The two dimensional (2D) velocity of the debris was found to be 119 ft/sec and the length of the debris was approximately 10.8 inches. This debris did not appear to strike the vehicle. For more details and a plot of the debris distance versus time see Appendix D, Task #7.

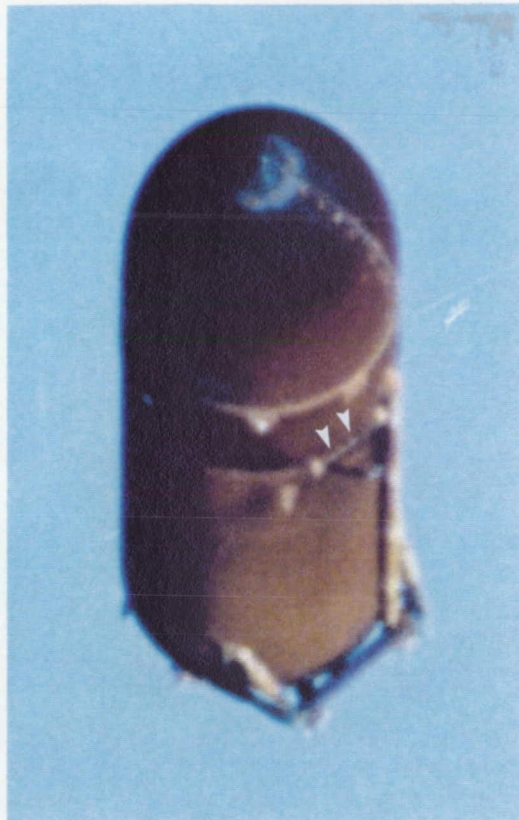
**Figure 2.4.1 (B)****Handheld Camera View of the Nose and -Y/+Z Axis of the ET (Frame STS-54-28-024)**

Magazine 28 showed the aft dome, nose and the left side (-y/+z axis) of the ET. Several possible divots were seen between the legs of the forward bipod on the above view. The divots seen on the handheld films showing the +Z axis of the ET were confirmed during the analysis of the 35mm umbilical well photography.

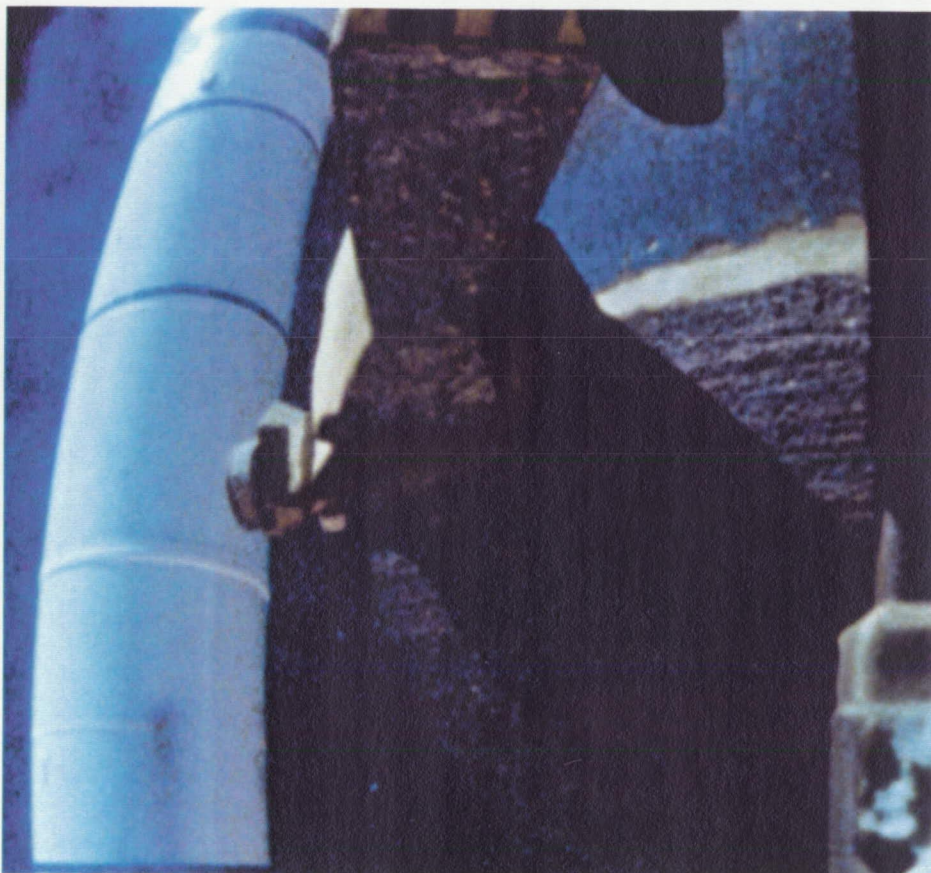
**Figure 2.4.2.1**                      **16mm View (5mm Lens) of Left SRB Separation**  
(Frame STS-54-57-1464)

Separation of the left SRB from the external tank appeared normal on this 16mm umbilical well camera. No anomalies were observed on the left SRB. Multiple divots were visible on the base of the external tank electrical cable tray. Multiple small pieces of debris [possibly chips or flakes from the thermal protection system (TPS)] were in view throughout the entire SRB separation sequence. Small pieces of the TPS were seen to ablate from the ET electrical cable tray. The aft ET/Orbiter attach brace and the ET aft dome showed charring similar to that seen on previous mission's umbilical films.

Numerous pieces of small debris were seen in the 16mm umbilical camera views of the left SRB before, during and after SRB separation. The debris appeared to be small pieces of TPS that had ablated off the external tank.

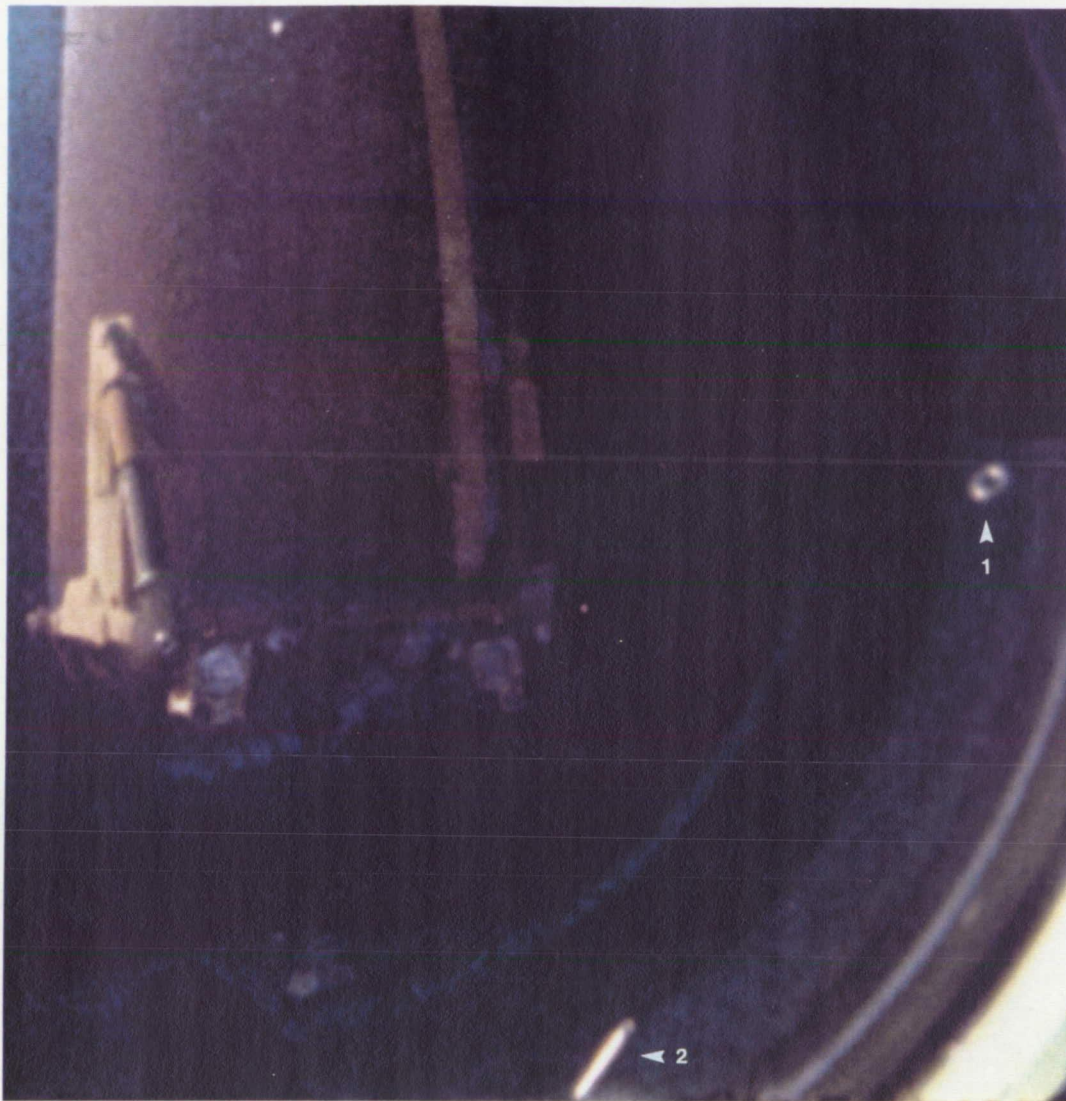
**Figure 2.4.2.2.2 (A)**

Three objects appeared in the LH2 ET/ORB umbilical camera field of view after the External Tank had separated and moved some distance away from the Orbiter (IFA STS-54-I-01). A metallic washer; metallic cotter pin, or bolt; and nylon wire tie/identifier (or possibly some white RTV from a red seal repair) have not been positively identified as flight hardware, but appeared to originate from the LH2 ET/ORB umbilical area and may have been entrapped in the numerous cavities of the umbilical prior to purge barrier closeout. The IFA was closed by modifying the inspection requirement and procedure. Film analysis also showed orbiter flight performance, landing gear extension, wheel touchdown, and vehicle rollout after landing were normal.

**Disk Shaped Debris and Rod Shaped Debris Visible after ET Separation (Frame STS-54-57-7446)**

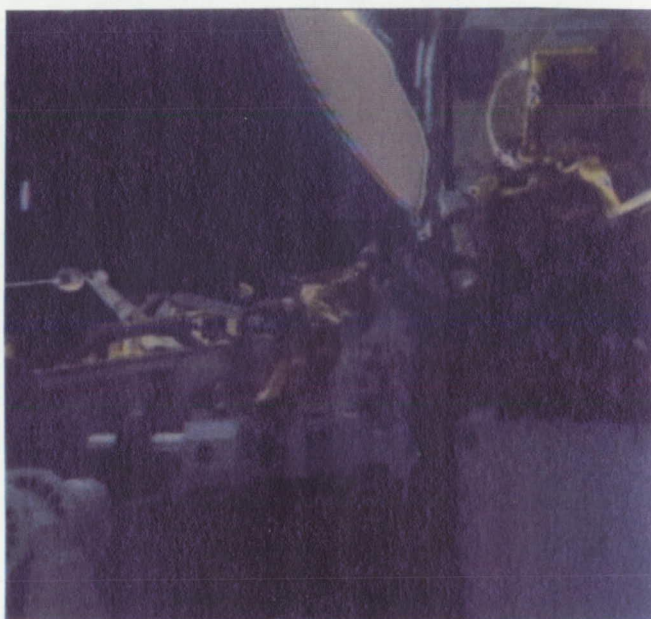
Figure 2.4.3

Numerous pieces of debris were observed on orbit from the Payload Bay Camera A between 13:22:01:44 UTC and 13:22:21:31 UTC after the Tracking and Data Relay Satellite (TDRS) deploy. Payload Bay Camera A was pointed toward the aft end of the Orbiter and none of the debris appeared to originate from within the payload bay. Most of the debris were small, but three large pieces were chosen for more detailed study as well as one small slow moving piece of debris that moved in an arced trajectory. The exact origin or composition of this debris is unknown (The most likely explanation is that the debris was ice from a water dump.) since the debris does not pass in front of a known object, the exact distance from the camera to the debris cannot be determined. Without knowing the debris' origin or its distance from the camera, the true size and velocity of the debris cannot be determined. The larger pieces of debris are, however, seen to pass behind the aft edge of the payload bay and this does allow for a minimum distance to be determined; therefore, a minimum size and velocity can also be found.

Debris Observed near Payload Bay

For this study the debris was assumed to be close to the Orbiter and at the distance of the aft +y corner of the Payload Bay. (This represents a minimum distance since the debris was seen to be beyond the Payload Bay.) The distance from the camera to the aft +y corner of the payload bay was found to be approximately 726 inches. Another assumption was that all the debris motion

The second large piece of debris, seen at 13:22:12:06 UTC, was very large, rectangular in shape and was tumbling. Like the first large piece of debris, it was also observed toward the aft end of the payload bay on the +y side. The debris moved both in the +z and +y direction until it disappeared from the FOV. The minimum size of the object was approximately 3.2 inches x 3.4 inches x 1.2 inches and the approximate minimum velocity was 3 inches per second. The tumble rate of the debris was approximately 514 degrees per second.

A small slow moving piece of debris was noted to move in a curved trajectory at 13:22:14:29.749 UTC. This debris was unusual because it moved very slowly compared to the other debris and it moved in a curved trajectory (almost all the other debris was seen to move in a straight line trajectory). The debris was approximately 0.8 inches in length and the minimum 2D velocity of the debris was found to be .81 feet per second.

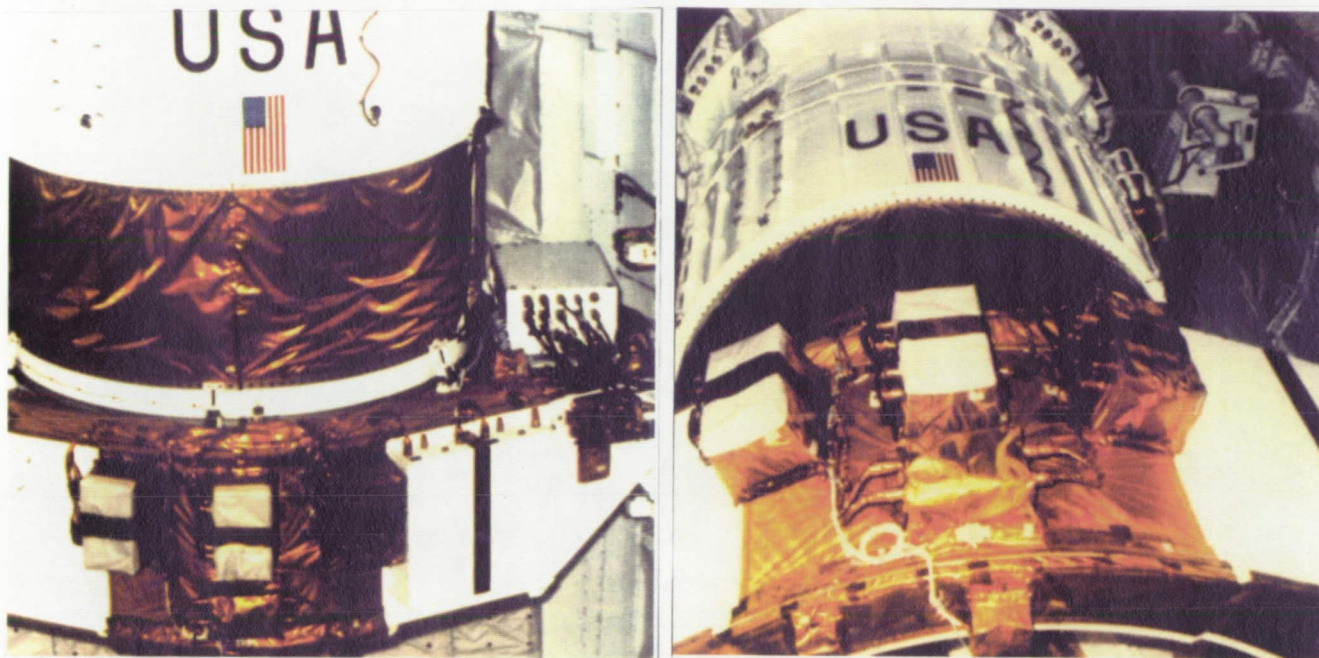
**Figures 2.4.4 (A) and (B) Prelaunch Closeout Views of the Batteries**

A visual comparison was made between the closeout views and the onboard video views. No obvious signs of damage to any of the six batteries or associated structures could be detected. The edges of the battery boxes appeared straight and the covers to the battery box appeared intact (similar to the closeout views). The multi-layer insulation wrapping on the batteries was not seen to be torn, discolored or misshapen at the level of detail present in the INCO's videos. The multi-layer insulation covering over the individual batteries did have a "wrinkled" appearance which was consistent with the prelaunch closeout pictures. No liquid or vapor was detected in any of the onboard video views. The following is a summary by individual camera:

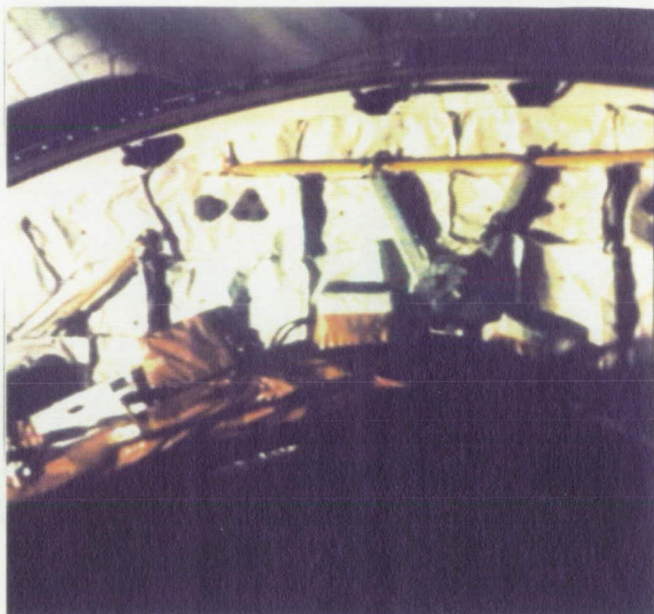
**Figure 2.4.4.1**

#### **View of Batteries from Payload Bay Camera A**

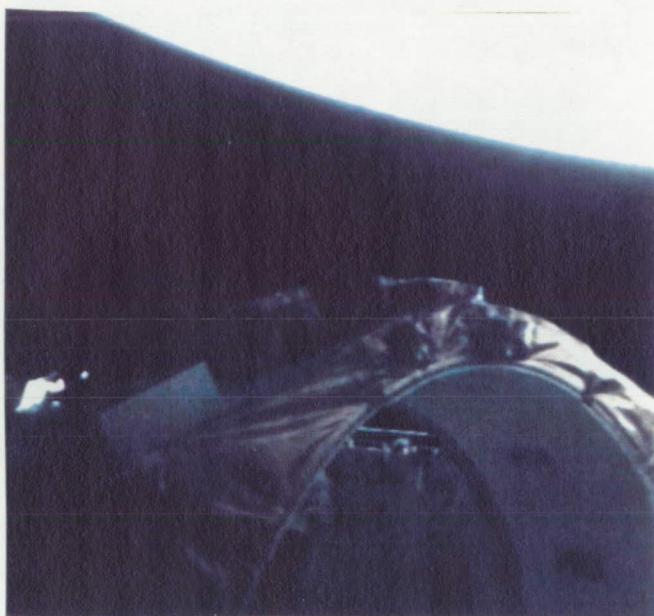
**Figure 2.4.4.2**

**View of Batteries from Payload Bay Camera B**

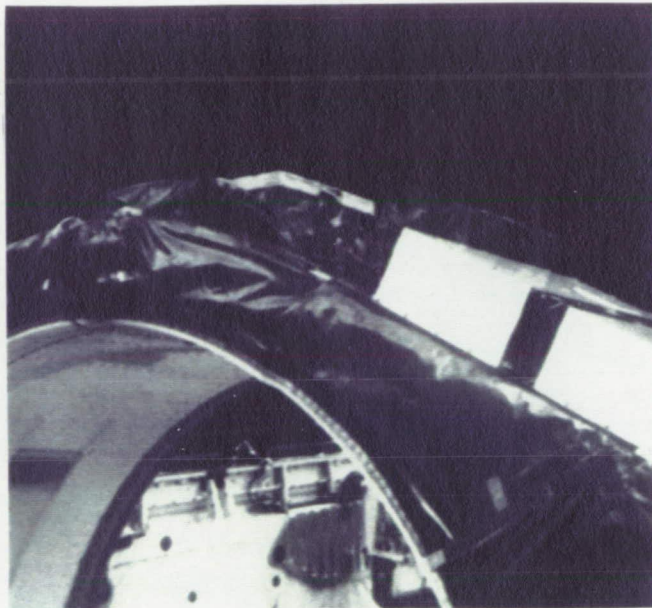
**Figure 2.4.4.3**

#### **View of Batteries from Payload Bay Camera C**

The visible portion of the starboard aft battery appeared in very good condition. The right side of the forward and aft center batteries were uneven in appearance - probably due to a wrinkling of the multi-layer insulation. The tops of the two batteries had a normal appearance. The tape-like stripping material between the two center batteries had an uneven appearance but this could not be confirmed to be abnormal due to the lighting and viewing angle.

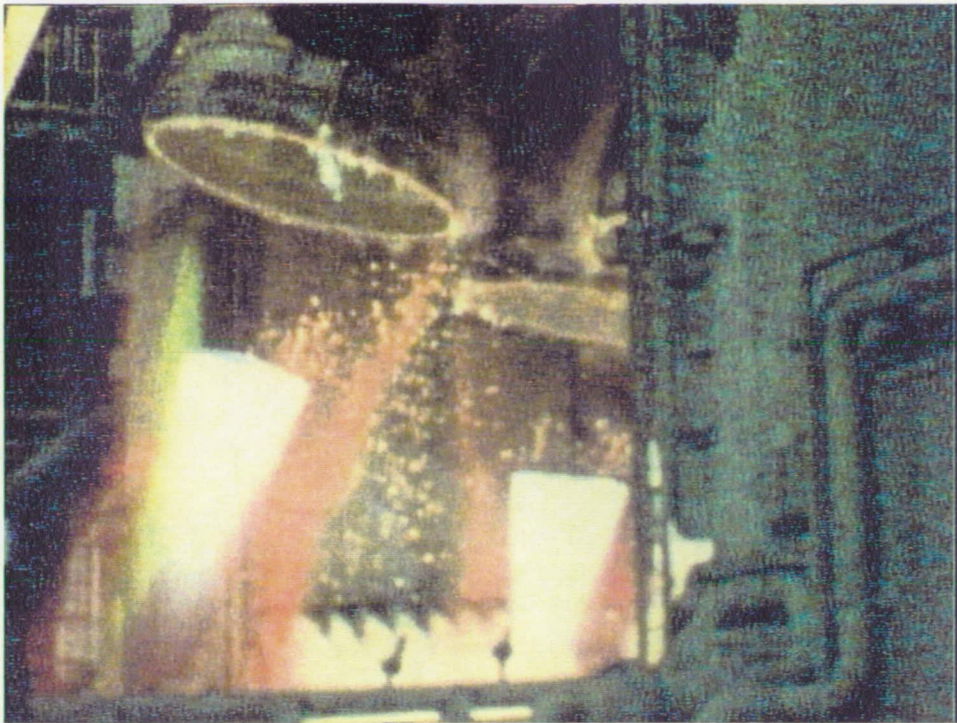
Figure 1

Green Streaks Noted in SSME #1

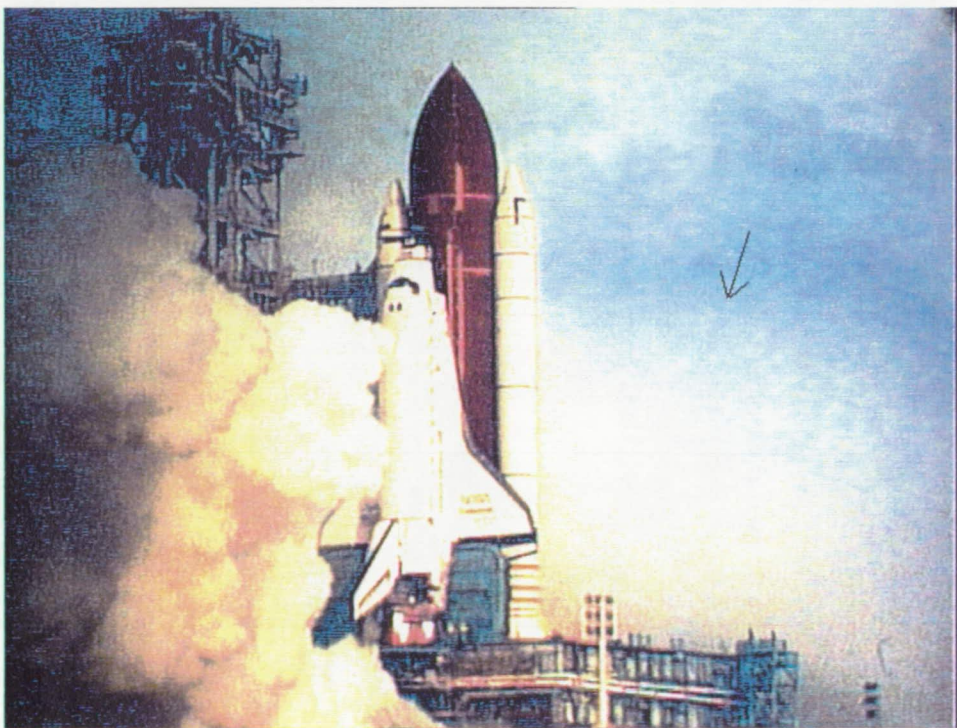
Figure 2

Large Condensation Cloud

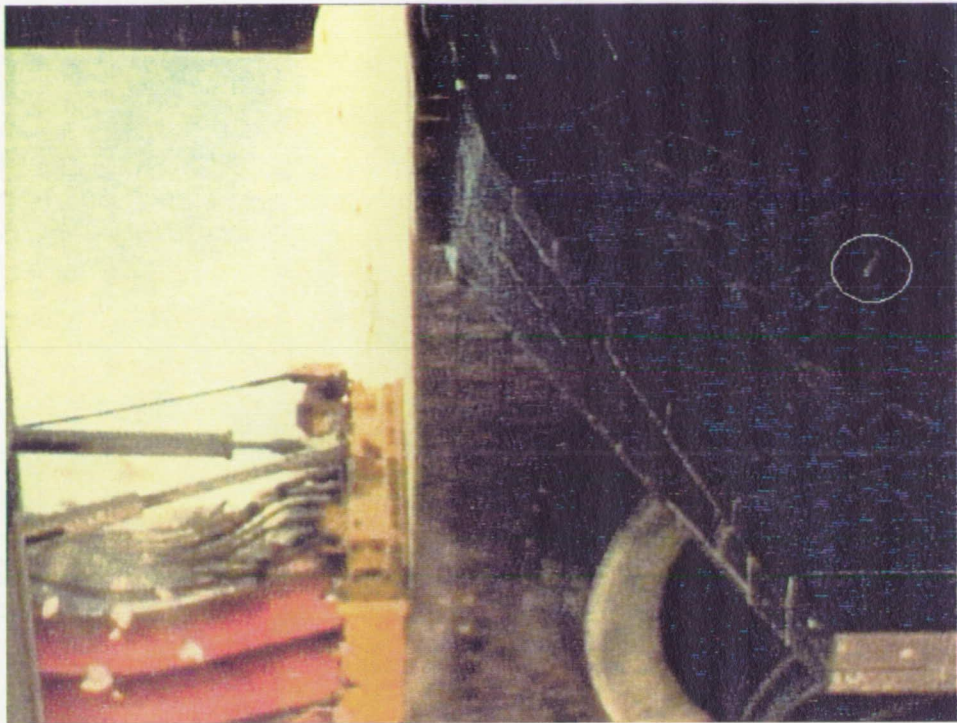
Figure 3  
Debris From Body Flap Area

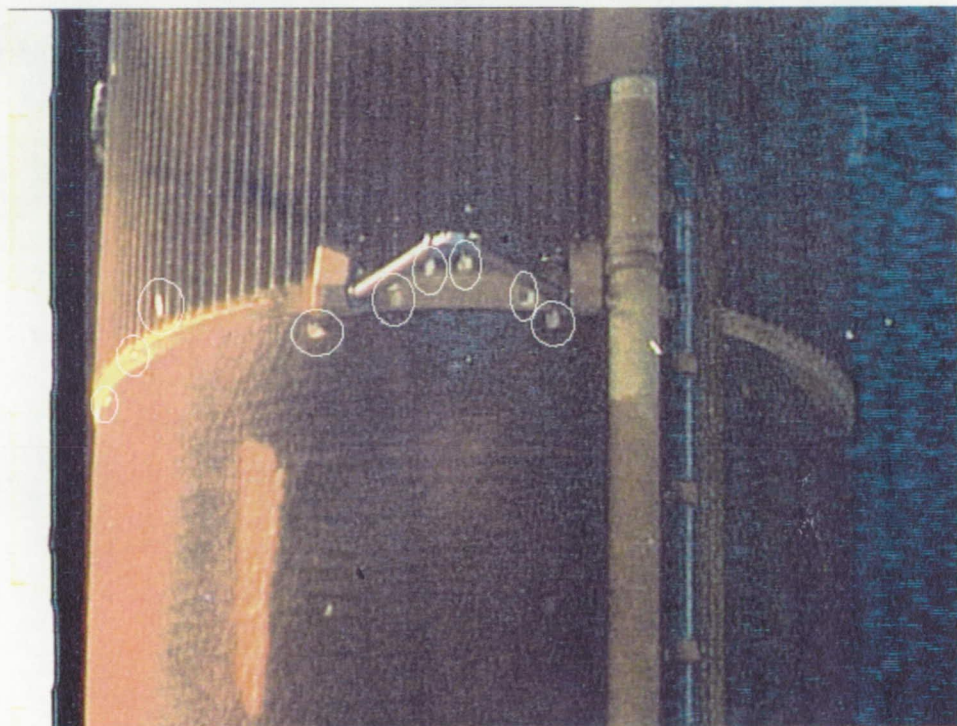
Figure 4  
TPS Divots  
132

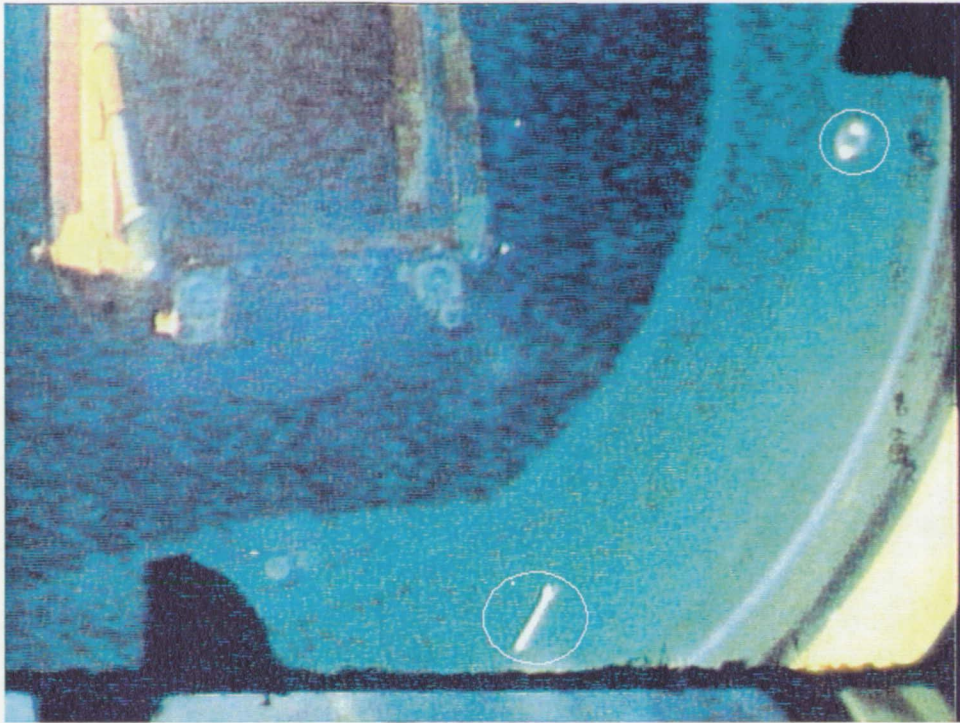
Figure 5  
ET Separation Debris
